WOOD CHIP PILOT PLANT CONTAMINATION ASSESSMENT

Umvoto Africa (Pty) Ltd. (hereafter Umvoto) were appointed by The Environmental Practice (Pty) Ltd. to undertake a high-level contamination assessment for a pilot “wood chip” processing plant established on Erf 299 in Atlantis Industria, City of Cape Town Metropolitan Municipality, Western Cape Province. This letter outlines potential contamination associated with the pilot plant, and related activities, for the period February 2021 – July 2021. The assessment is done in support of the Section 24G application currently underway in terms of the National Environmental Management Act ([NEMA] Act No.107 of 1998).

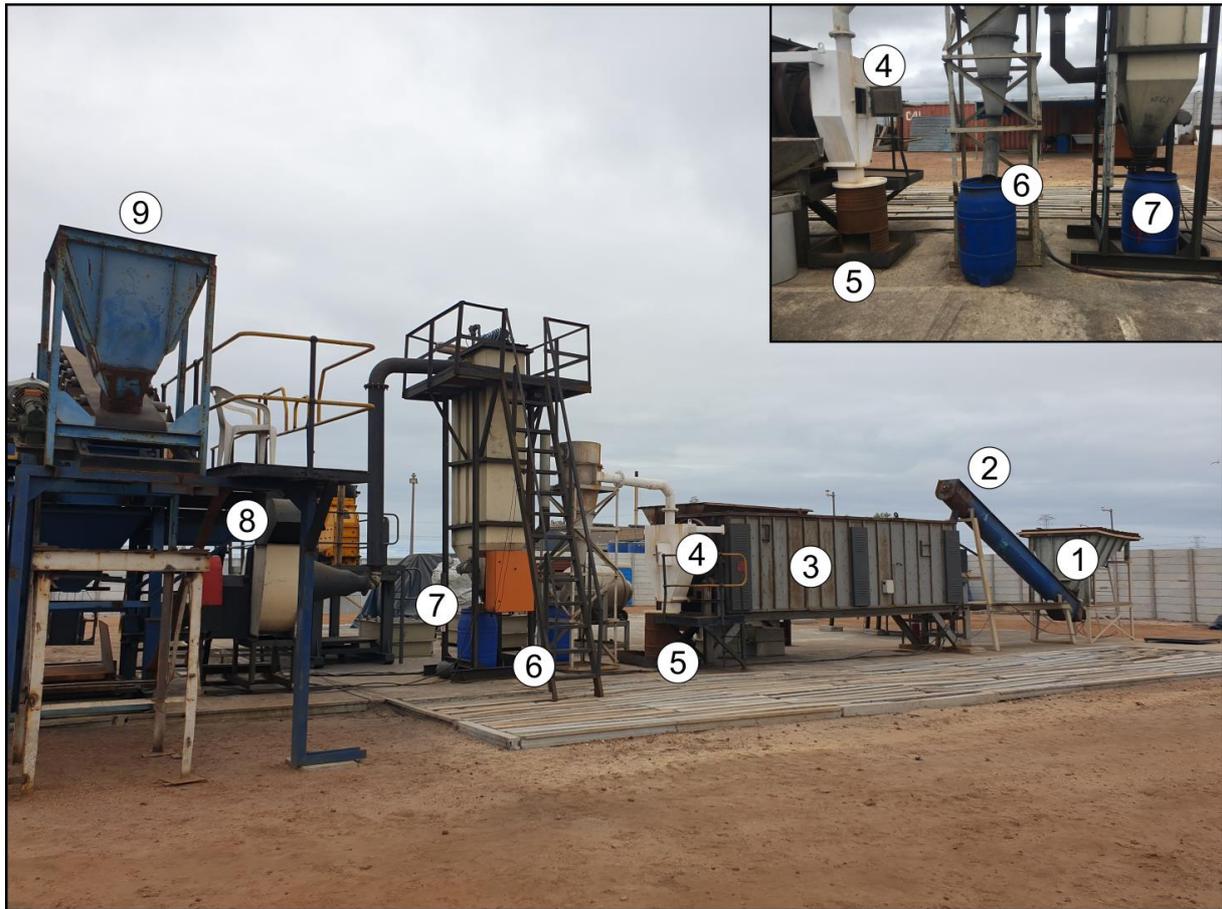
Figure 1 Photograph taken by Umvoto of the pilot plant for processing of “wood chip”. Components of the plant are labelled 1-8. (1) Telehandler loads feedstock into hopper from bags. (2) Feedstock is transferred from hopper via open screw conveyor belt into rotary kiln. (3) Feedstock is burned in rotary kiln at ~800-900°C. (4) Unfiltered aerosol emissions and dust from kiln door. (5) over size drop-out box and catchment tray. (6&7) Cyclone and filtered fines dropping into uncovered drum. (8) Filtered air discharge. (9) Limited trial screening of feedstock undertaken.

The final outcomes in **Table 1** show negligible to low contamination associated with the activities on site. Recommendations for future contamination mitigation include reducing aerosol emissions/deposition, keeping the feedstock and product areas dry, appropriate bunding and impermeable surfaces for fuels and chemicals, drip trays, spill kits and a Stormwater Management Plan (SWMP) for separation of dirty and clean water (underway). Small scale leachate tests to assess the mobilization of contaminants when the feedstock or product gets wet is recommended to account for uncertainty in the Safety Data Sheet (SDS). Additional processes planned for a full-scale plant (processing of rubber liners and spent carbon) are addressed separately in an assessment for the full-scale plant.
